## Agulhas National Park - Access for the Mobility Impaired Guests

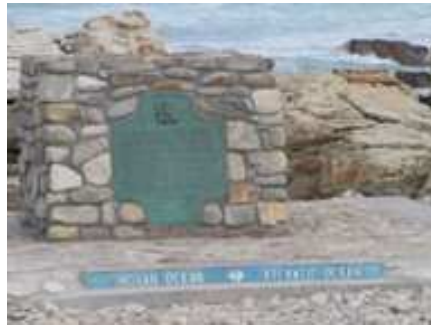
Perhaps the primary attraction in the park is the **Southern Tip of Africa**, where the Atlantic and Indian Oceans meet. A new boardwalk (April 2010) now takes visitors from the parking area to the southernmost tip. A smooth, wide and firm surface is flanked on both sides by guide ropes, but there is no kick plate at the side to prevent front wheels of a wheelchair rolling off ... but as the walkway is sufficiently wide this shouldn't be a problem.

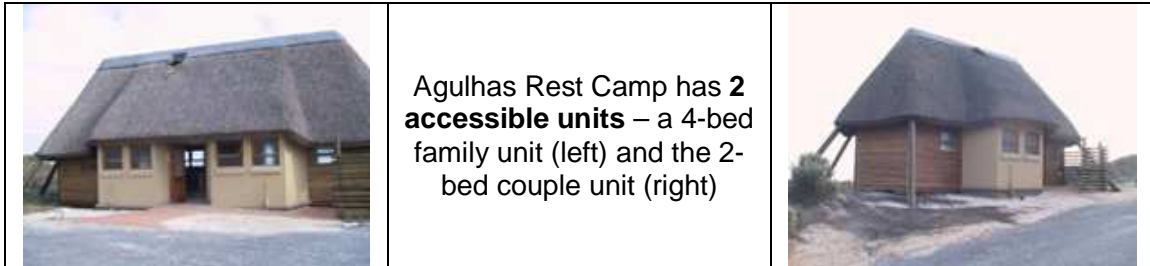
The entrances to both units are provided for by smooth wide bricked pathways. The 4-bed unit is a shallow gradient (below left), with the entrance to the 2-bed unit a little steeper (below centre). There is also a small ridge at the entrance to the 2-bed unit (below right) which may hinder some folk. *(alternate pictures to be supplied by park manager with improvement to entrance to 2-bed unit)*

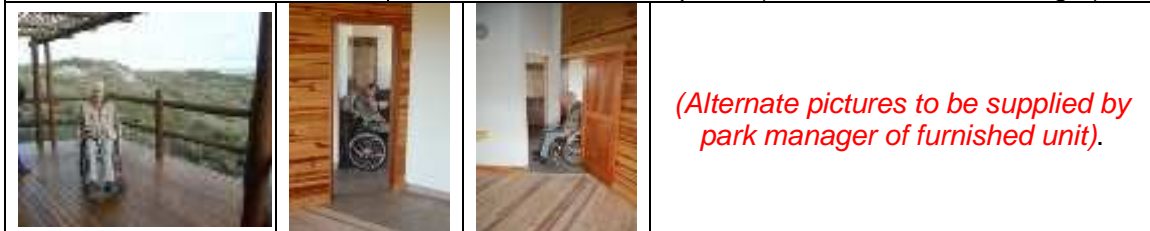
In the **4-bed unit** the open plan kitchen/living area (once fully furnished) will be relatively accessible, although there is no clearance below the sink. *(Alternate pictures to be supplied by park manager of furnished unit)*. This central area leads onto a spacious balcony (below left) and into 2 bedroom chambers, one of which is equipped with accessible facilities. The access to the ablutions is narrower than is required (below centre left and right).

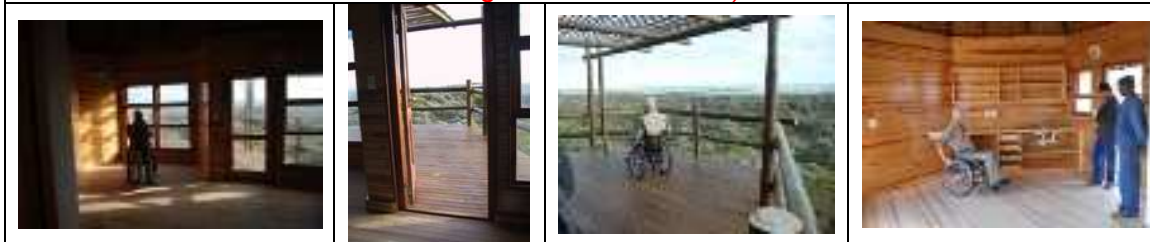
The interior layout of the **2-bed unit** also has a central open plan kitchen/living room area and this leads onto the balcony, where there is a small ridge to negotiate and into the bedroom chamber, where the gap left by the sliding door needs to be widened. The kitchen facilities are relatively accessible, *(Alternate pictures to be supplied by park manager of furnished unit)*.

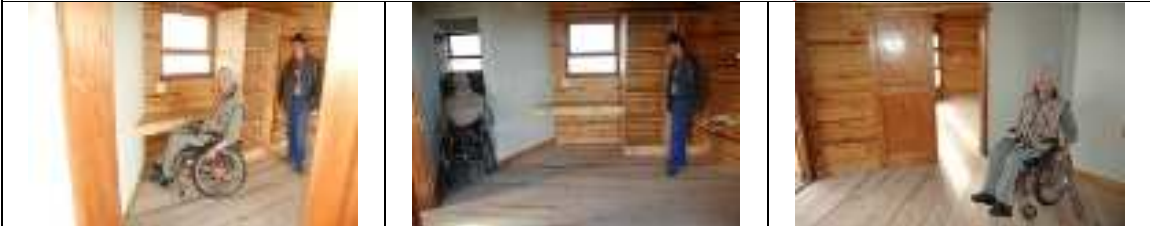
The bedroom has the following concerns:

1. The unit's bedroom chamber will have an issue with the layout of the bed, so that

there is sufficient space alongside the right hand side of the bed to allow access for a wheelchair user to this side of the bed and the wardrobe

2. The shelf adjacent the wardrobe is too low and a wheelchair user cannot get underneath. (below left)
3. Access from the bedroom into the en suite ablutions is a much tighter width than required (below centre)
4. The width of the door from the living room is too narrow and needs to be widened (below right)

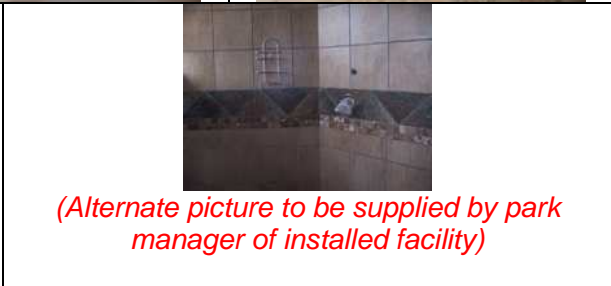
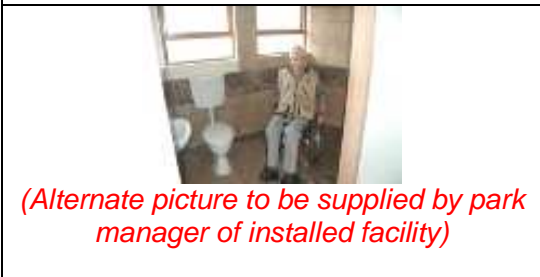
Both units have a similar roll-in shower layout. As the walls of the shower are at an obtuse angle to each other, a hinged grab rail has had to be provided to enable guests in wheelchairs to use the facility.

The accessible toilets in both units are not adjacent a wall, but a basin vanity and open on the one side. While a rear grab rail is a standard requirement, a fold-down hinged grab rail or a standing one mounted to the floor will be required. The basin is in reach of the toilet.

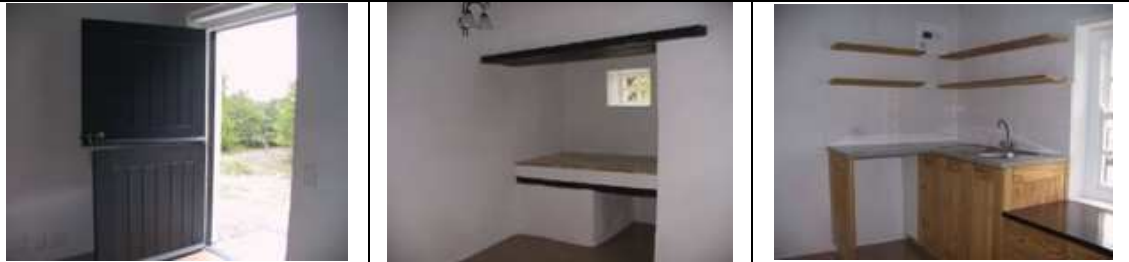
On entering the facility one is in a living space/open plan kitchen. Images of the empty space prior to being furnished are shown below. The unfurnished layout is relatively accessible, but once a fridge, dining room table, sleeper couch etc has been added, the accessibility of the spatial layout will have to be judged. *(Alternate pictures to be supplied by park manager of furnished unit).*

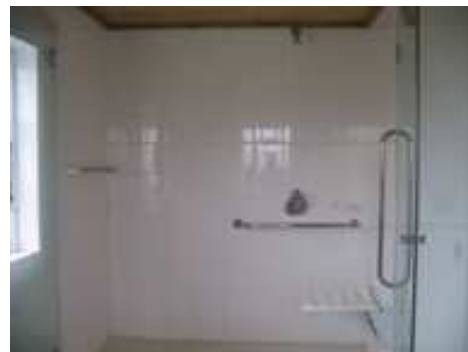
The unit's ablution is particularly spacious. The toilet is fitted with grab rails and its flusher is on the accessible side, while and the basin has push levers and the mirror is well positioned. The one criticism is that the basin is a fraction too far from the toilet to use with complete comfort

The unit's shower is wonderfully spacious with 2 transparent swing doors that open up to maximise the space. The roll-in shower's fold-up seat is of the appropriate size and the 2 support rails are well positioned. The mixer is a push style one and the only short-coming is that there is no detachable shower head on a height adjustable sliding pole, but only a standard fixed outlet point near the ceiling. *(Alternate pictures to be supplied by park manager of corrected shower)*
